Safety Inspection Report

Annual Inspection

Recreation Ground

11 August 2023

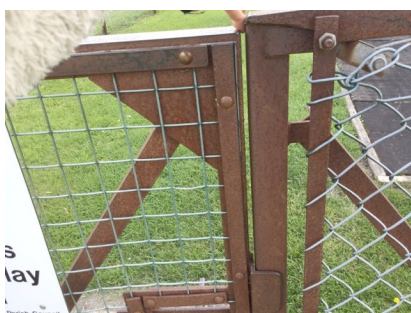
Gates

There is a crushing or shearing point on the side of the gate. Where the gaps reduce to less than 12 mm these have been known to cause serious, permanent injury to children, especially on the hinge side where the leverage forces are significant.

On the opening side. Consider fitting a buffer which prevents the gate from closing fully so the minimum gap is 12 mm.

Adjust gate / posts / fit new rubber buffer to ensure a spacing of at least 12 mm throughout the range of the gate to remove the entrapment. The 12 mm gap also should apply on the hinge side of the gate.

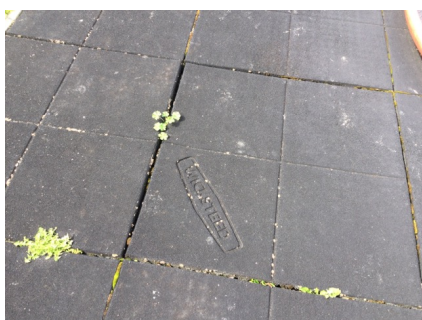
General Surface

Shrinkage / separation of the surface. This may give a trip hazard.

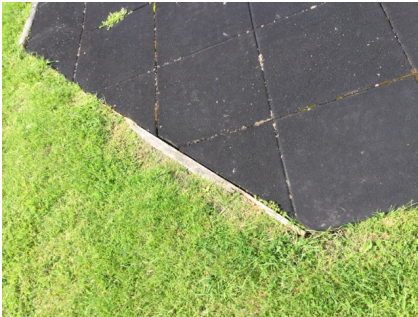
Timber is not in good condition.

Timber edging is rotten in places with potential for large shards to become loose and misused. Trip hazards are formed where the timber edging is missing. Remove rotten timbers and fill the gaps with topsoil to level the ground. Intact timber edging does not need to be removed.

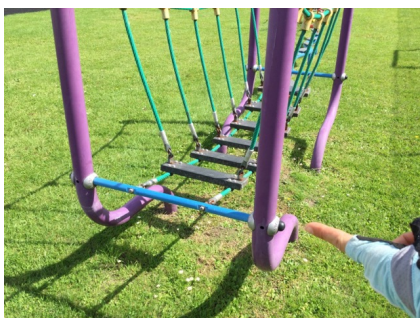
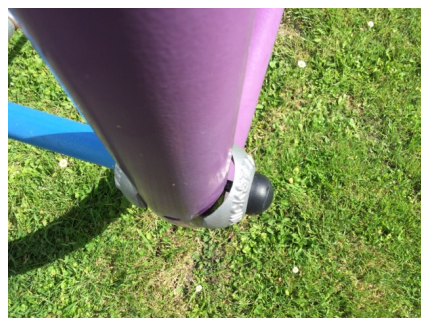
Agility Trail

Bolt(s) loose.

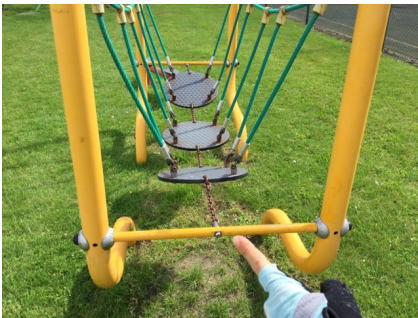
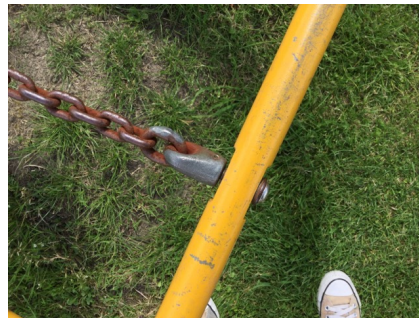
Bolt(s) loose.

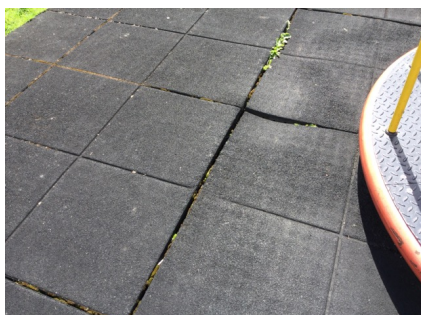
Carousel

Gaps have opened up between tiles causing trip hazard.

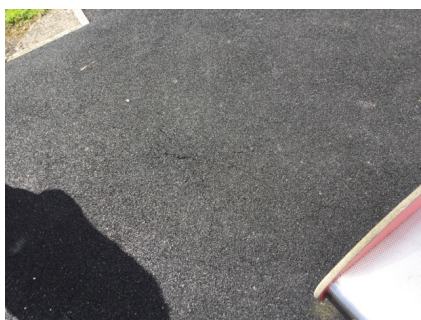
Multiplay

The wet pour surface is cracking.

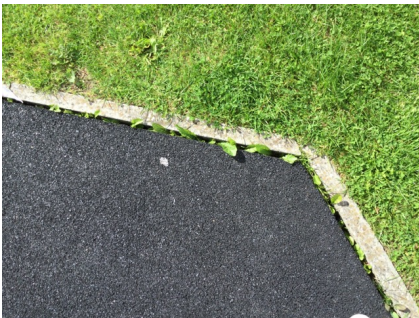
Shrinkage / separation of the surface. This may give a trip hazard.

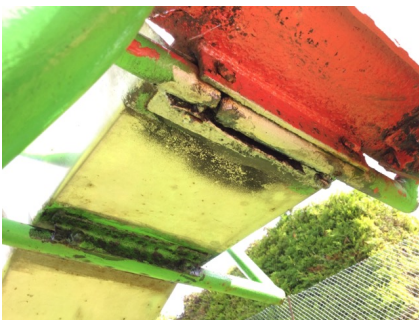
Slide

Item has corrosion.

The framework has corrosion, particularly advanced in the last-but-one step which can collapse under load.

Treat and repair.

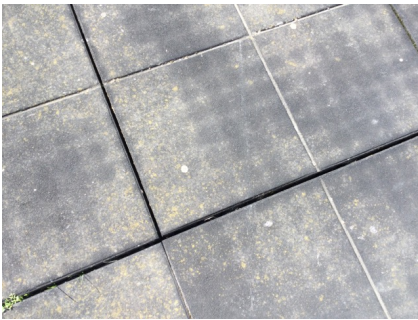
Swing - Junior - 1 Bay 2 Seat

Gaps have opened up between tiles causing trip hazard.

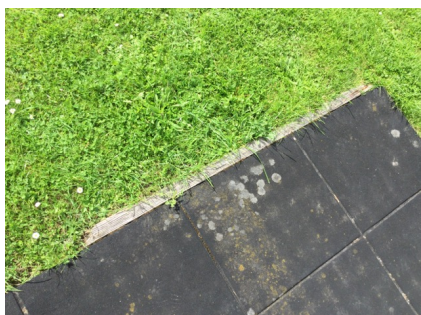
Swing - Toddler - 1 Bay 2 Seat

Rot in timber surround with potential for sharp splinters. Remove splinters when they appear and make the ground level to eliminate trip potential.
