Safety Inspection Report

Annual Inspection

Recreation Ground

11 August 2023

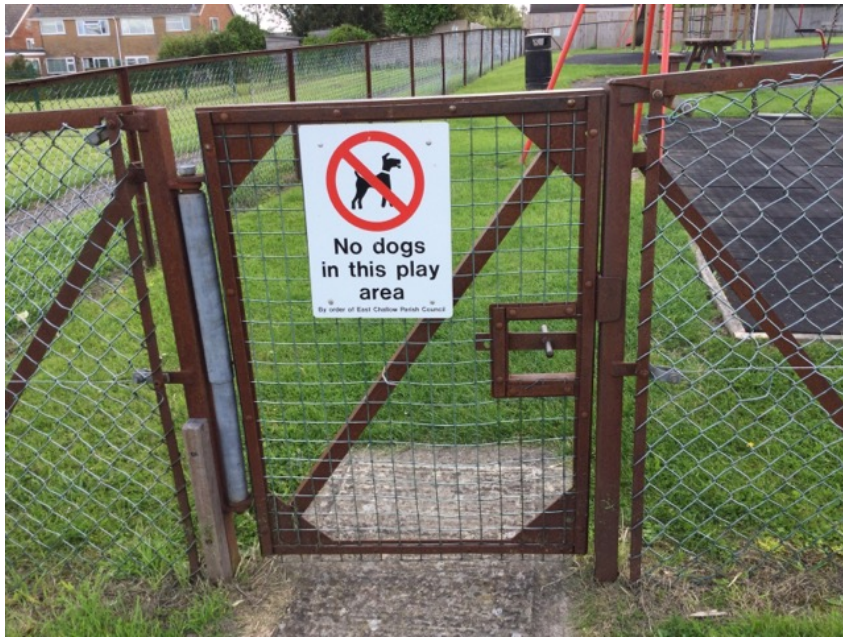
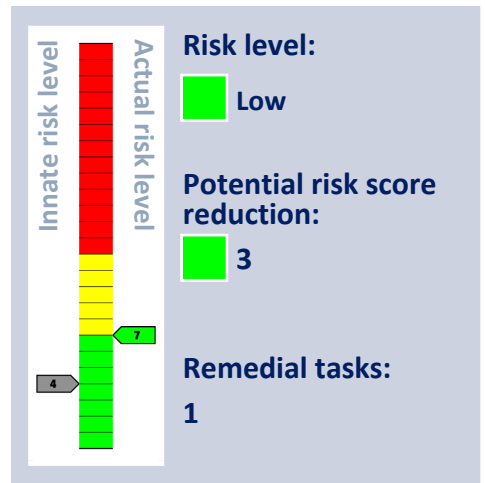
Gates

There is a crushing or shearing point on the side of the gate. Where the gaps reduce to less than 12 mm these have been known to cause serious, permanent injury to children, especially on the hinge side where the leverage forces are significant.

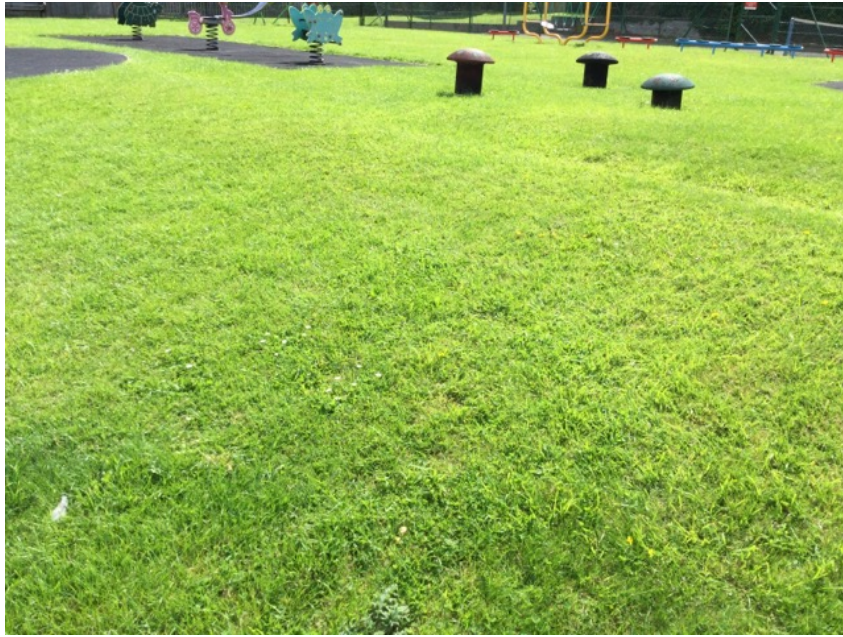
General Surface

Shrinkage / separation of the surface. This may give a trip hazard.

Timber is not in good condition.

Timber edging is rotten in places with potential for large shards to become loose and misused. Trip hazards are formed where the timber edging is missing. Remove rotten timbers and fill the gaps with topsoil to level the ground. Intact timber edging does not need to be removed.

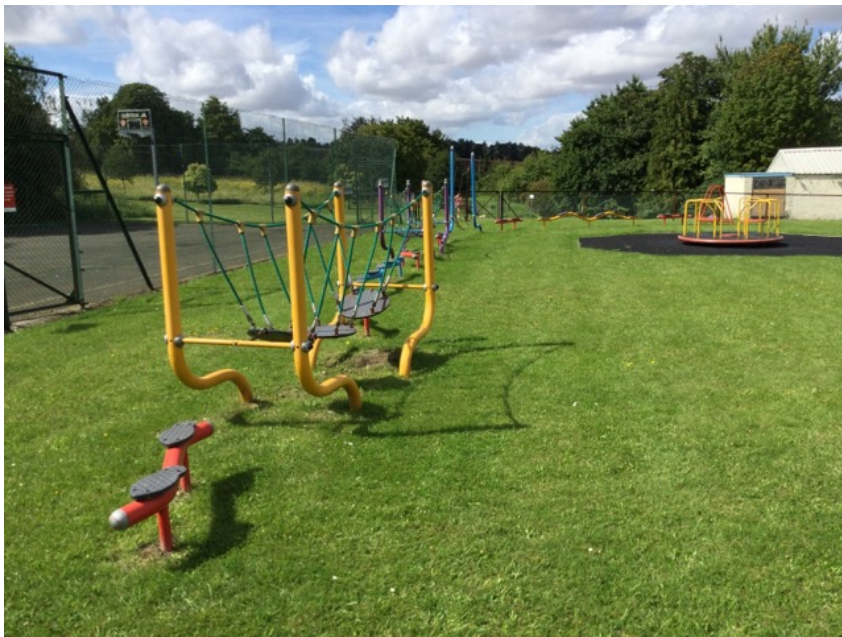
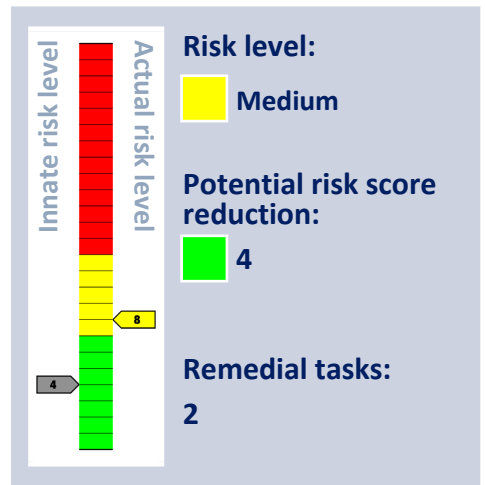
Agility Trail

Bolt(s) loose.

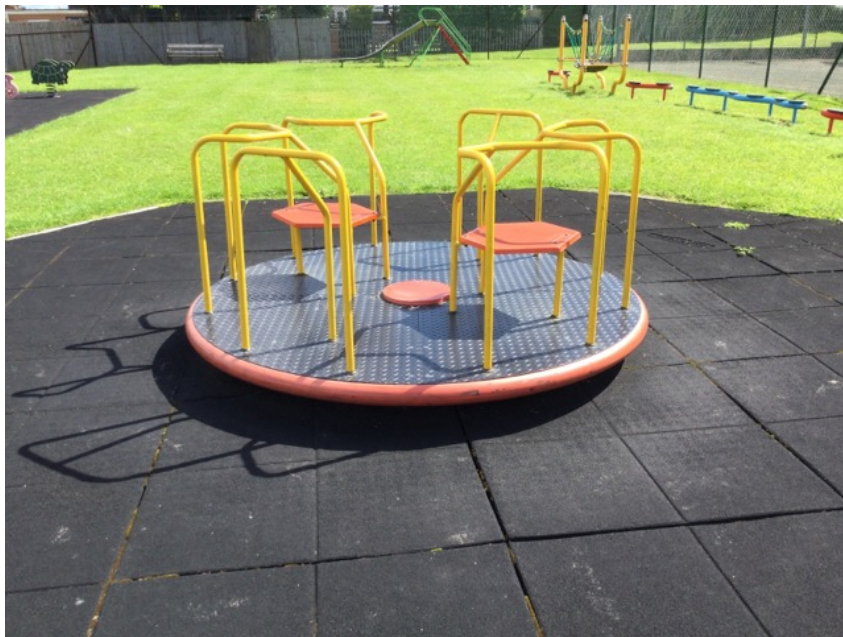
Carousel

Gaps have opened up between tiles causing trip hazard.

Re-install roundabout or adjust surfacing. Recommended height 60-110 mm for 300 mm from edge.

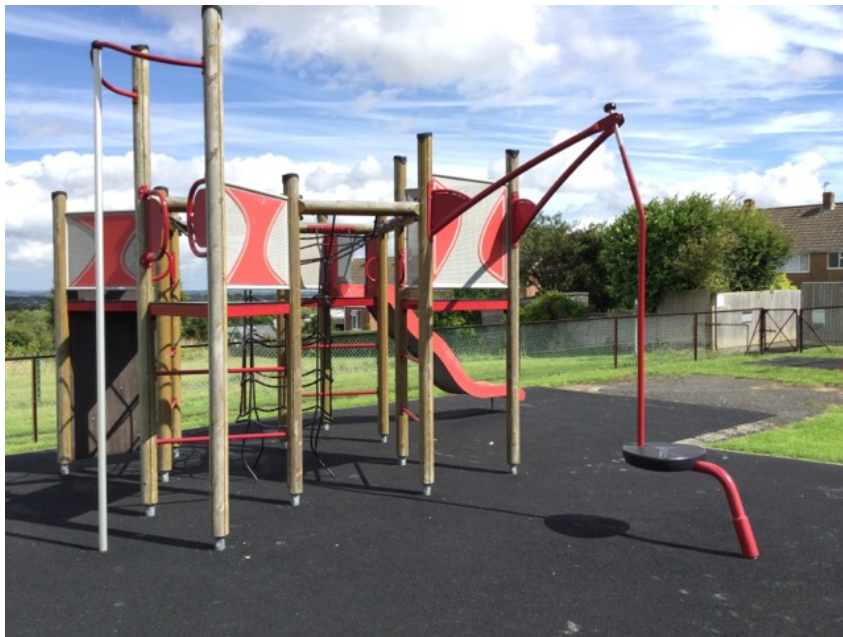
Multiplay

The wet pour surface is cracking.

Shrinkage / separation of the surface. This may give a trip hazard.

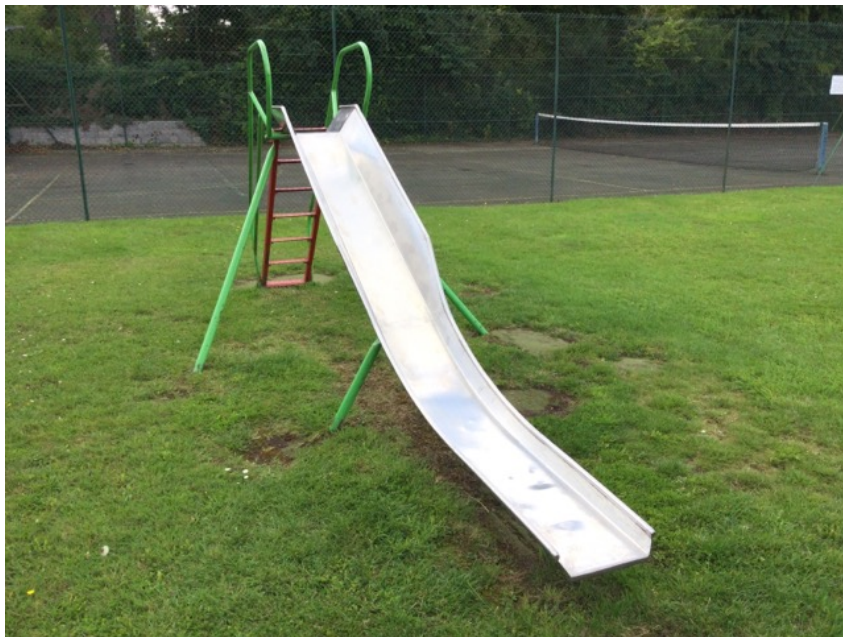
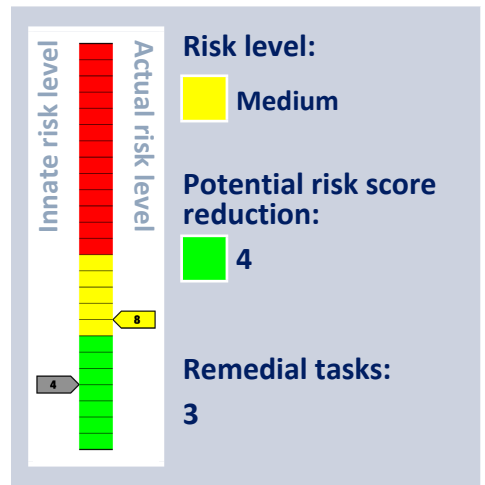
Slide

Item has corrosion.

The framework has corrosion, particularly advanced in the last-but-one step which can collapse under load.

Treat and repair.

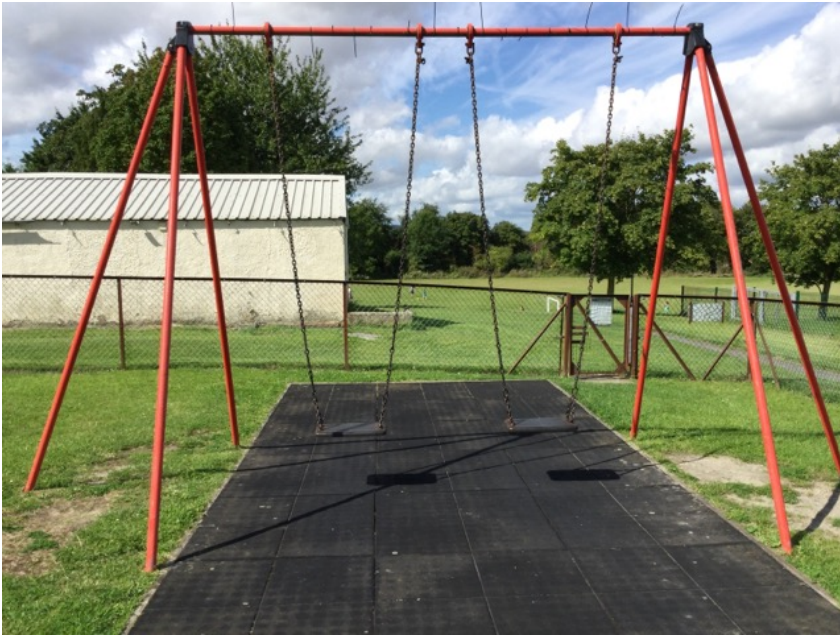
Swing - Junior - 1 Bay 2 Seat

Gaps have opened up between tiles causing trip hazard.

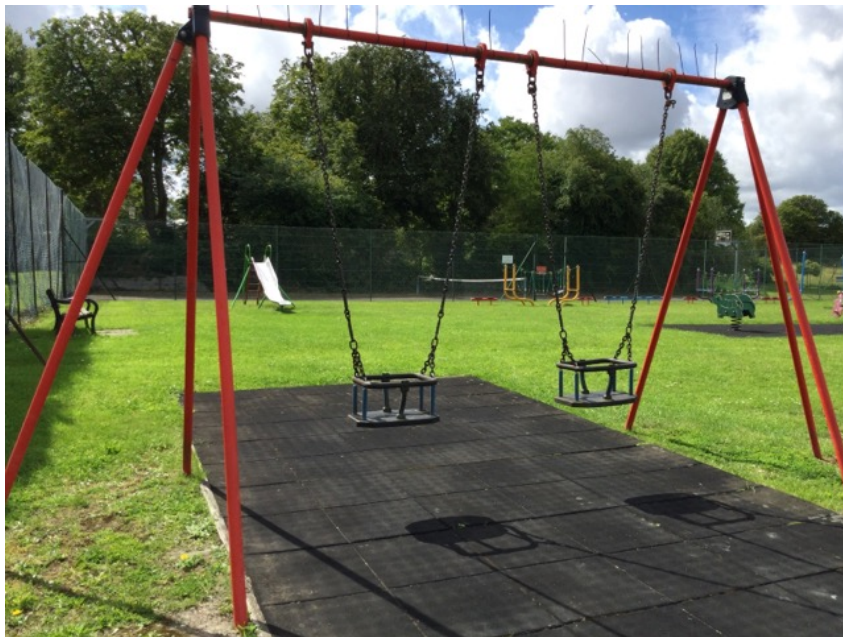
Swing - Toddler - 1 Bay 2 Seat

Rot in timber surround with potential for sharp splinters. Remove splinters when they appear and make the ground level to eliminate trip potential.
